Project: Aspendell Mutual Water Company -Reservoir Roof Replacement

Design Values for Avalanche Loading:

Estimation of avalanche snow depths and densities for the Aspendell water tank project

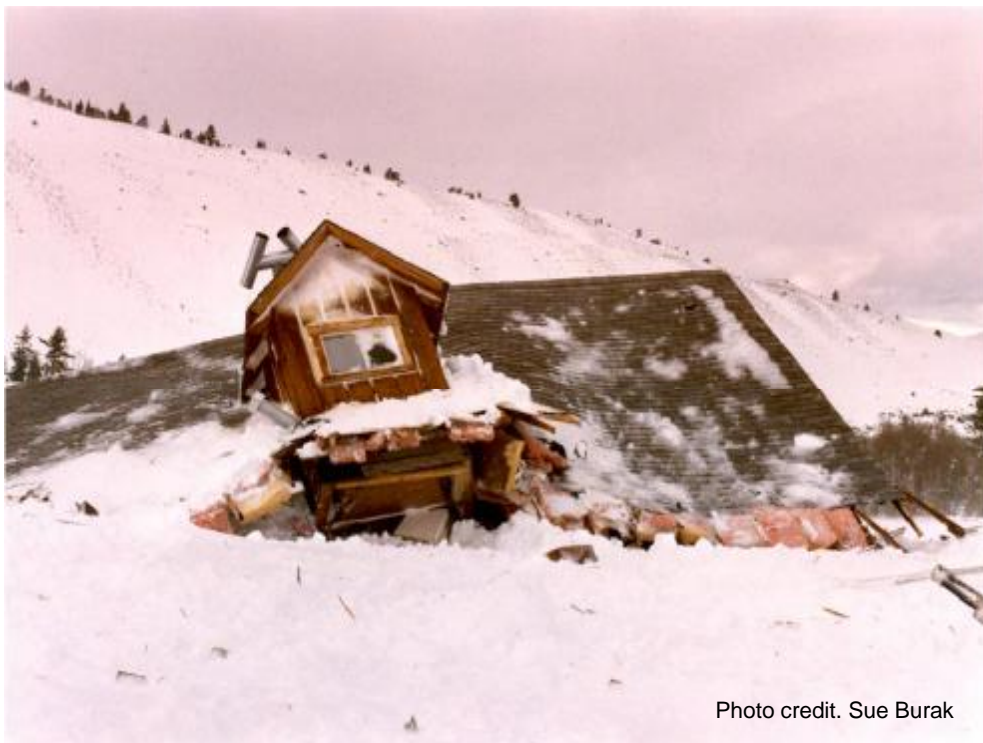
Figure 1. Knapp home after the February 1986 avalanche.

- Estimates of avalanche deposit depths around the heavily damaged Knapp house in February 1986 were made adjacent to the Knapp house (figure 1). The avalanche debris ranged from eight to 10 feet on the uphill side of the house.

There is evidence of debris flow and wet snow avalanche gouging on the Aspendell alluvial fan. The main channel feature is located near the base of the mountain on the east side of the alluvial fan. During the February 1986 avalanche, the channel was filled with prior snowpack and avalanche debris and the avalanche flowed laterally onto the alluvial fan and moved the home shown in Figure 1 at least 200 feet to the northwest (Mears, 1989).

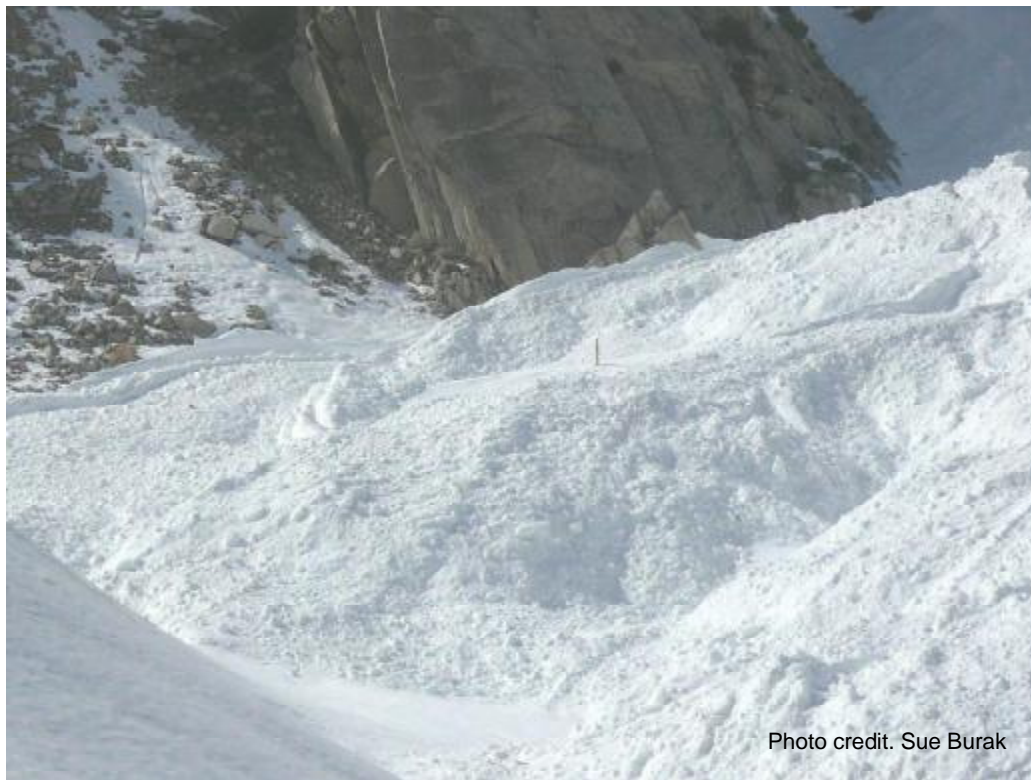
Figure 2. Wet snow avalanche, Pine Creek Canyon, March 28, 2011.

Mears identified the characteristics of the design avalanche that could reach Aspendell (Mears 1989). Dry flow avalanches may reach velocities of 95 mph. Powder snow air blasts that usually accompany large dry snow avalanches can blow out windows and doors and lift roofs off buildings. Design wet snow avalanches flow at slower velocities but can flow for long distances across low angle terrain because of reduced frictional resistance at the avalanche boundaries caused by the liquid water content of the snow (McClung and Schaerer, 2006). Large static loads often result because thick ridges of snow can produce crushing overburden pressures to structures. These slides can be destructive as thick ridges of snow subject structures to “crushing overburden pressure” (Mears 1989). An example of a large destructive wet snow avalanche is shown in figure 2.

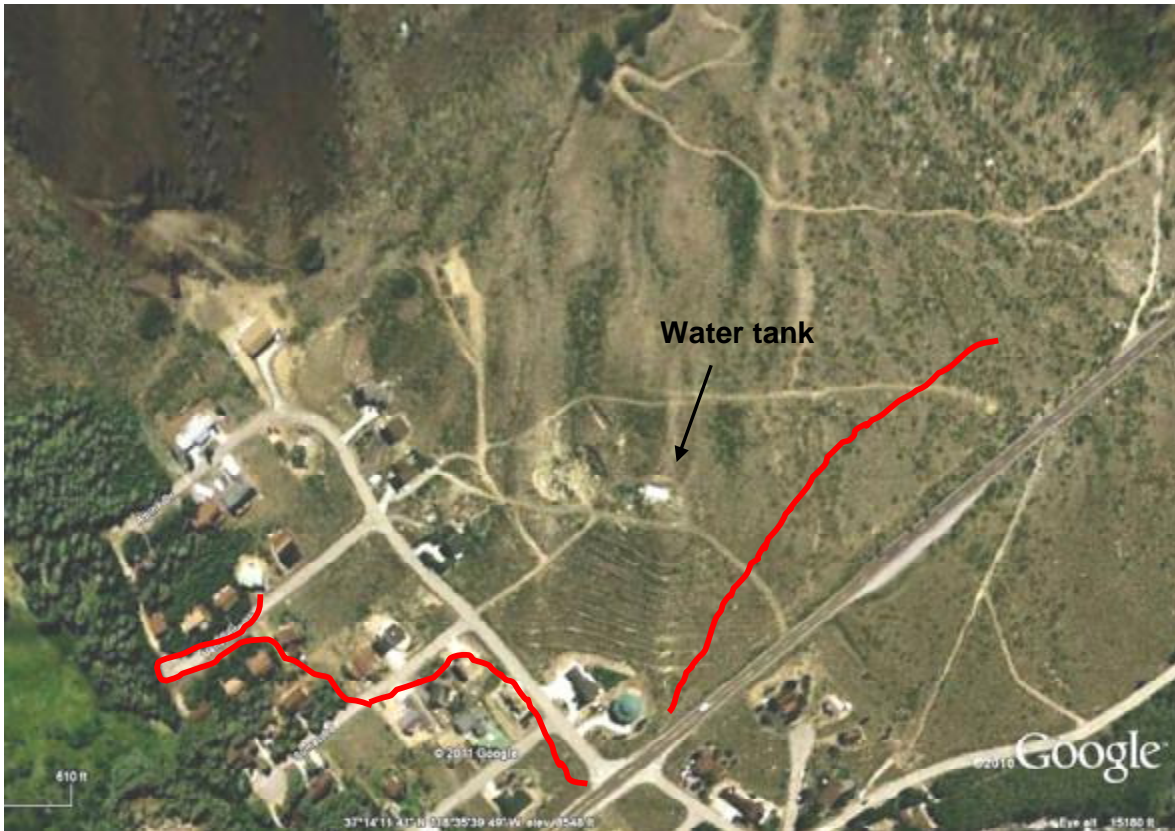
Figure 3. Google Earth image with historic avalanche runout drawn in red. The area around the intersection of Alpine Drive and highway 168 is blank because the historic boundary is uncertain. Adapted from Mears, 1989, figure 2-4.

Canyon alluvial fan and the eastern portion of the community of Aspendell. The red line represents the historic avalanche runout limits of all avalanche observations and study of 1955 aerial photographs (figure 2-4 in Mears 1989). Scale is 3.2" = 610 ft. Figure 4 is a high-resolution aerial photograph of the alluvial fan including the water tank.

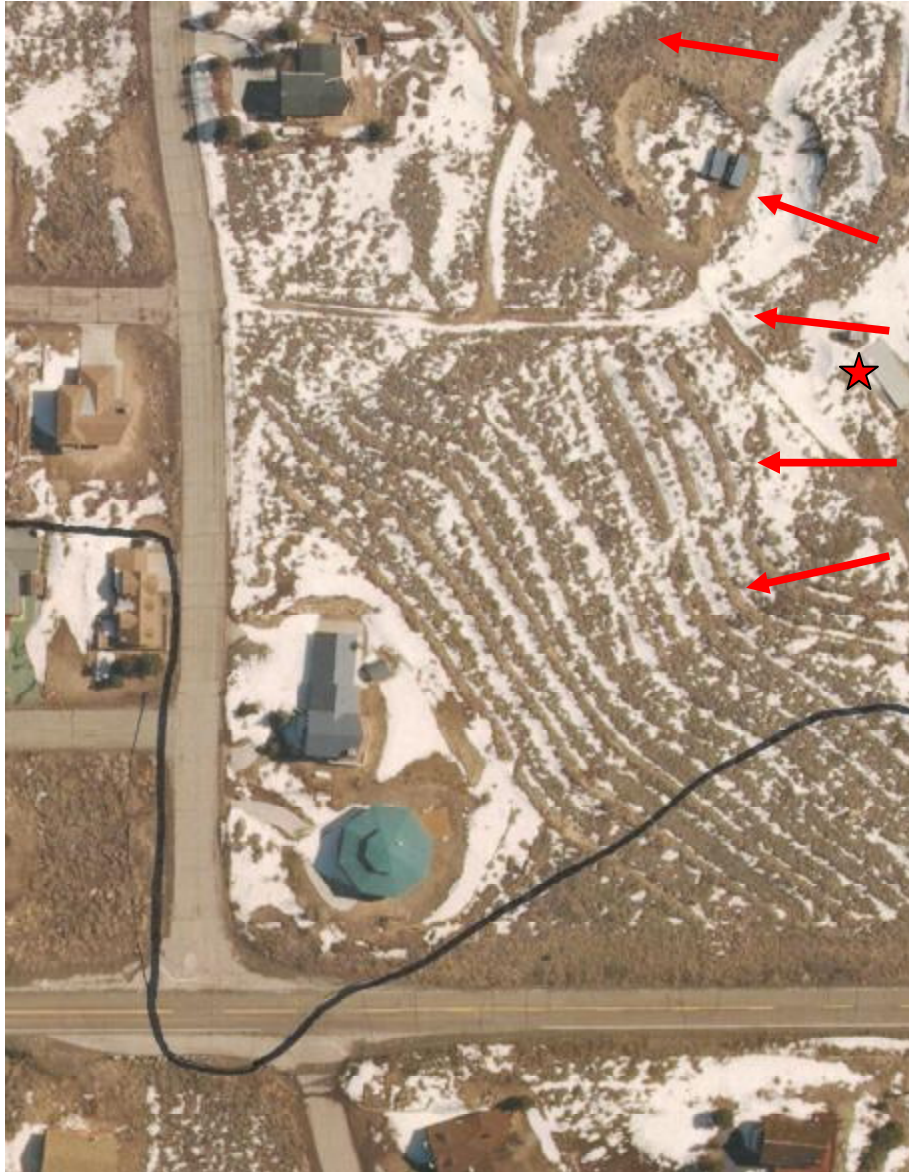
Figure 4. Aerial photograph water tank with avalanche flow directions as red arrows. The water tank is the rectangular building to the right of the star. Historic avalanche runout boundaries taken from Mears, 1989, figure 2-4.

The home destroyed in the February 1986 avalanche was located 465 ft to the northeast and 465 feet below the current water tank location on the alluvial fan. The tank site is subject to both dry snow and wet snow avalanches and is the highest elevation structure (8514 feet) on the alluvial fan. The location of the water tank relative to structures on Alpine Drive results in more exposure to avalanche flow.

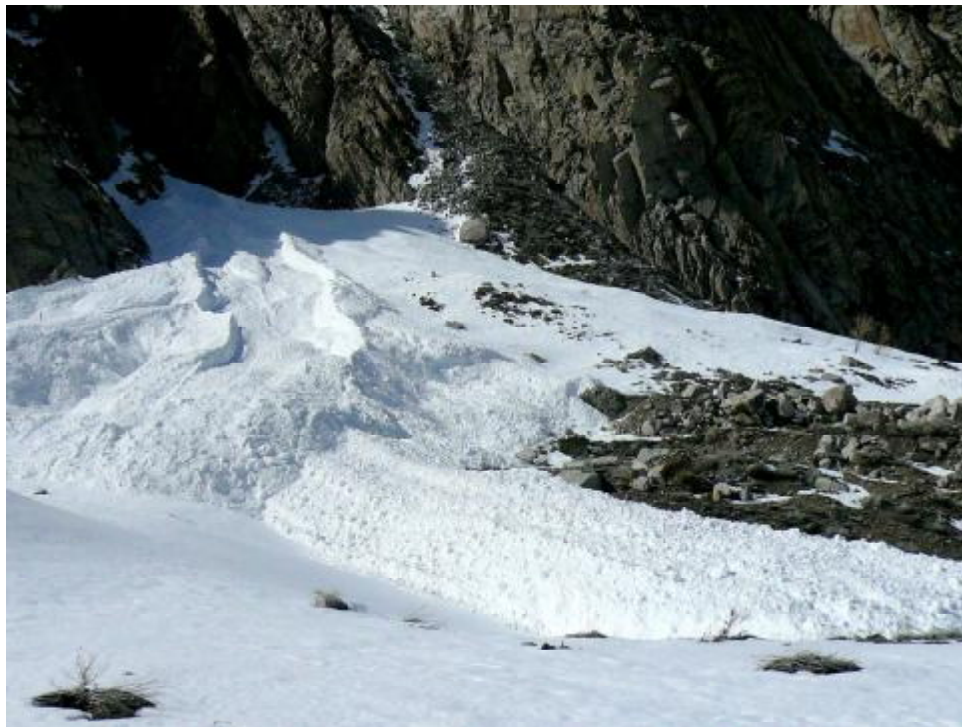
Figure 5. Pine Creek wet snow avalanche. Channels and levees are visible in the upper portion of the avalanche debris. Thick ridges of snow and separate flow fingers form thick impressive deposits and tongue shaped frontal lobes. One lobe of the avalanche flowed for approximately 1000 ft along an 8-10 degree slope shown in figure 5. The avalanche flowed from the steep canyon onto a mostly bare alluvial fan. Gouging into the dirt was not observed but may become visible as the avalanche deposits melt.

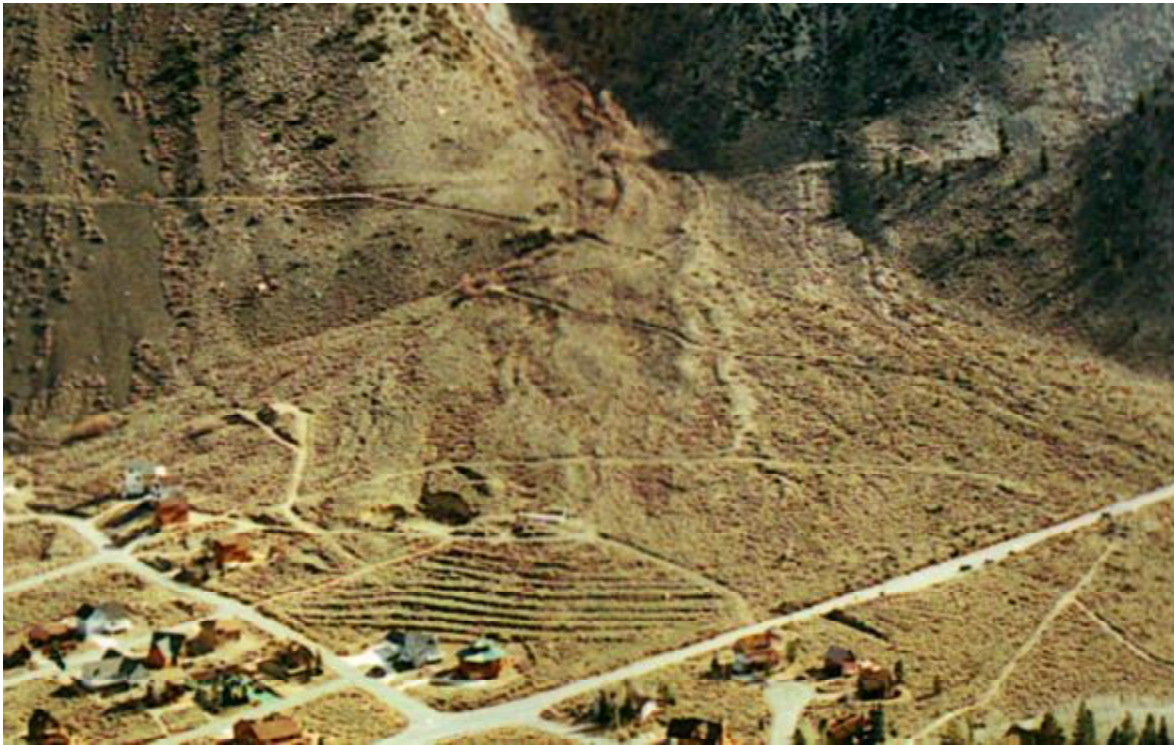
Figure 6. Photograph of Aspendell, fall 2002. Jim Archer photograph. A channel is seen extending from the left side of the top of the alluvial fan, along the base of the mountain in an east trending direction. A broad gully extends towards the water tank. Numerous runnel features are visible on the alluvial fan.

Closer examination of a Google Earth image (figure 7) of the alluvial fan reveals details of the channels seen in Figure 6.

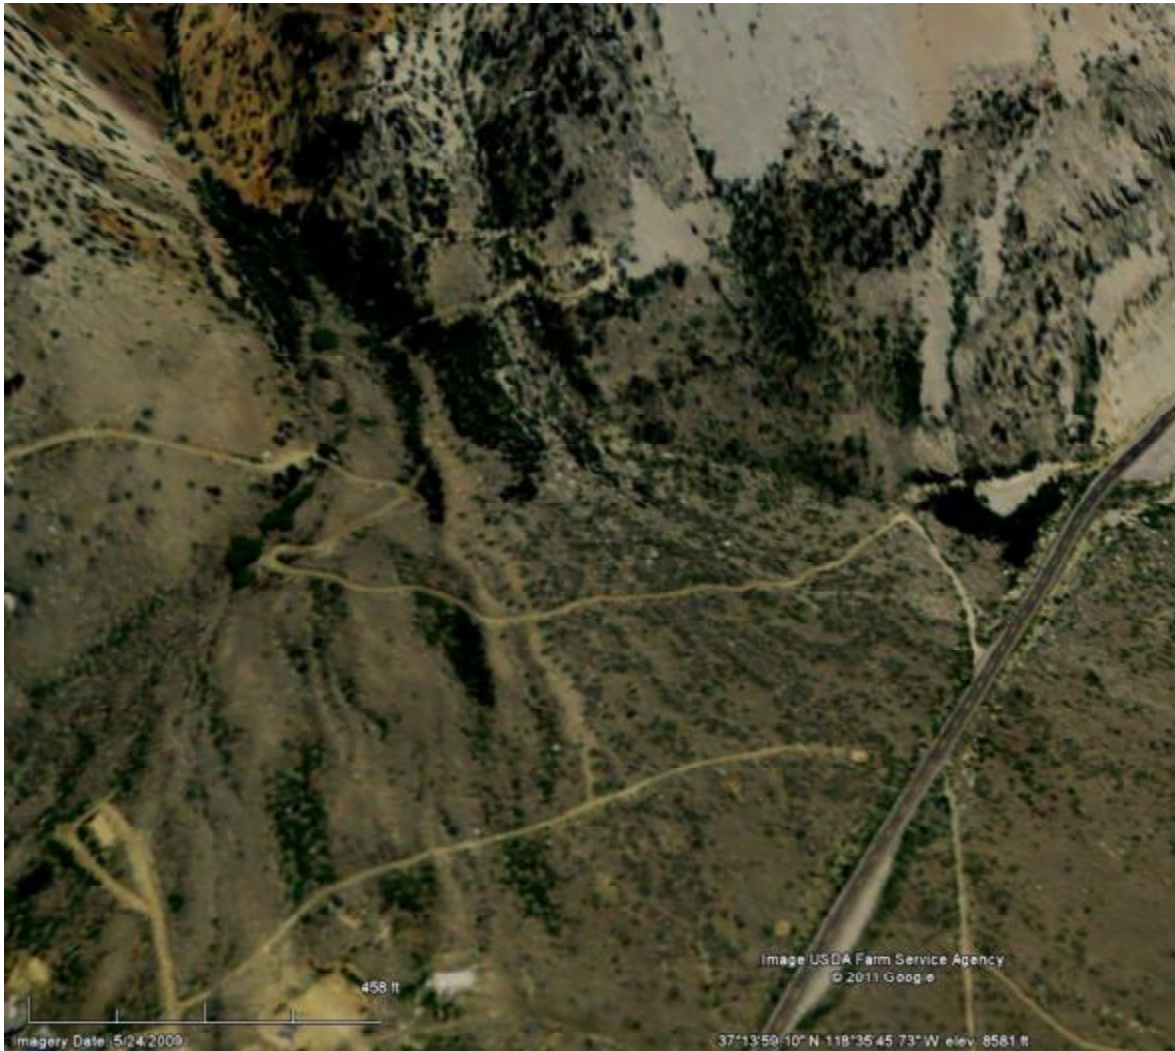
Figure 7. Google Earth image of alluvial fan. Scale 3.12" = 405 ft.

Three levee features are visible at the mouth of Jawbone Canyon. A northeast trending channel is visible along the base of the mountain that forms the left side of Jawbone Canyon. This channel diverts avalanche flow away from the community. The central levee feature forms the right boundary of a broad gully that could direct avalanche or mud/debris flow towards the tank site.

These features could be the result of wet snow avalanches or rock/mud debris flows resulting from snowmelt or torrential summer rainfall. As of the date of this report, further review of the alluvial fan features after the snow melts and the alluvial fan is bare, would help determine what measures will be needed to protect the tank.

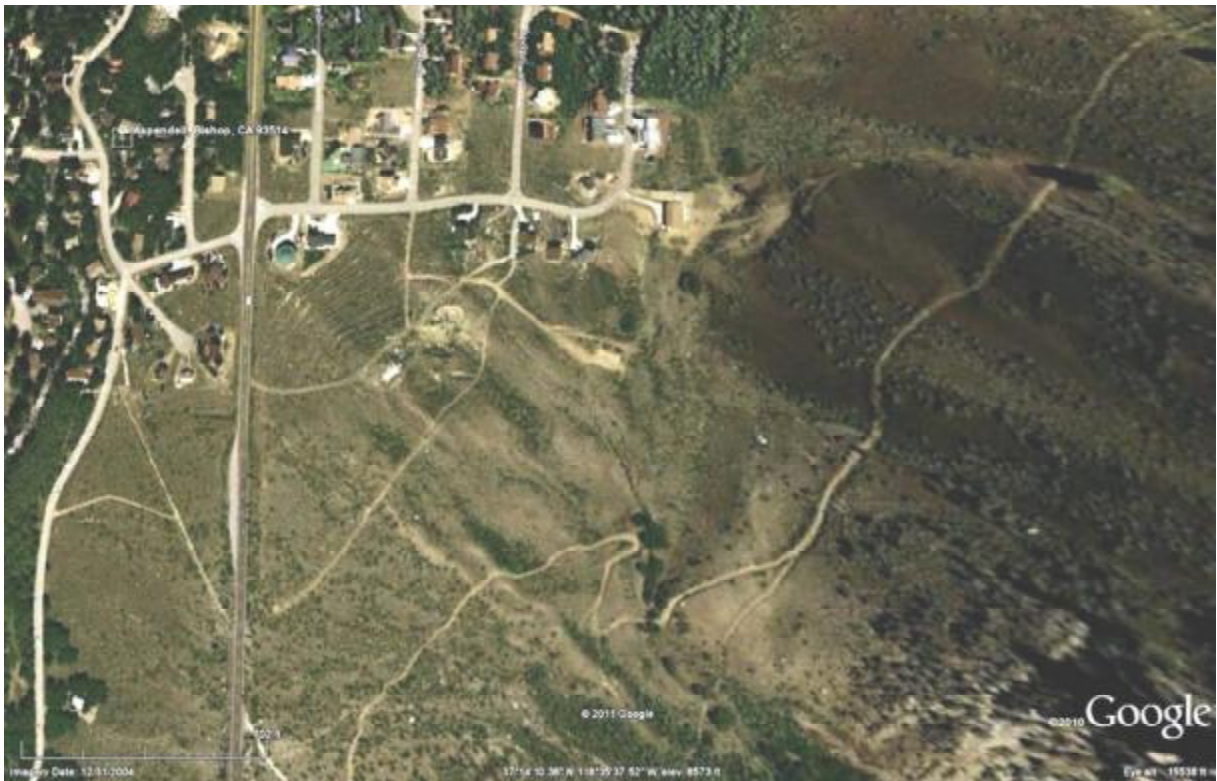
Figure 9. Google Earth image of Aspendell, 2004.

The area of riparian vegetation in the channel increased from 1988 to 2004. The grainy quality of the black and white images taken in 1988 and 1995 hinders detailed investigation of channel scour but the increased in riparian vegetation is evident. 2004.

While scour might occur in the water tank location, the presence of a pre existing channels would continue to both divert flow away from the tank and the community and possible direct flow towards the tank location. Further scour and earth gouging would likely occur in the established channel during a design avalanche.
